Re: Lake Merritt Pump Station Inspection  
Oakland, California  
MEG File No. 120469

# Lake Merritt Pump Station Inspected Component Locations February 2013

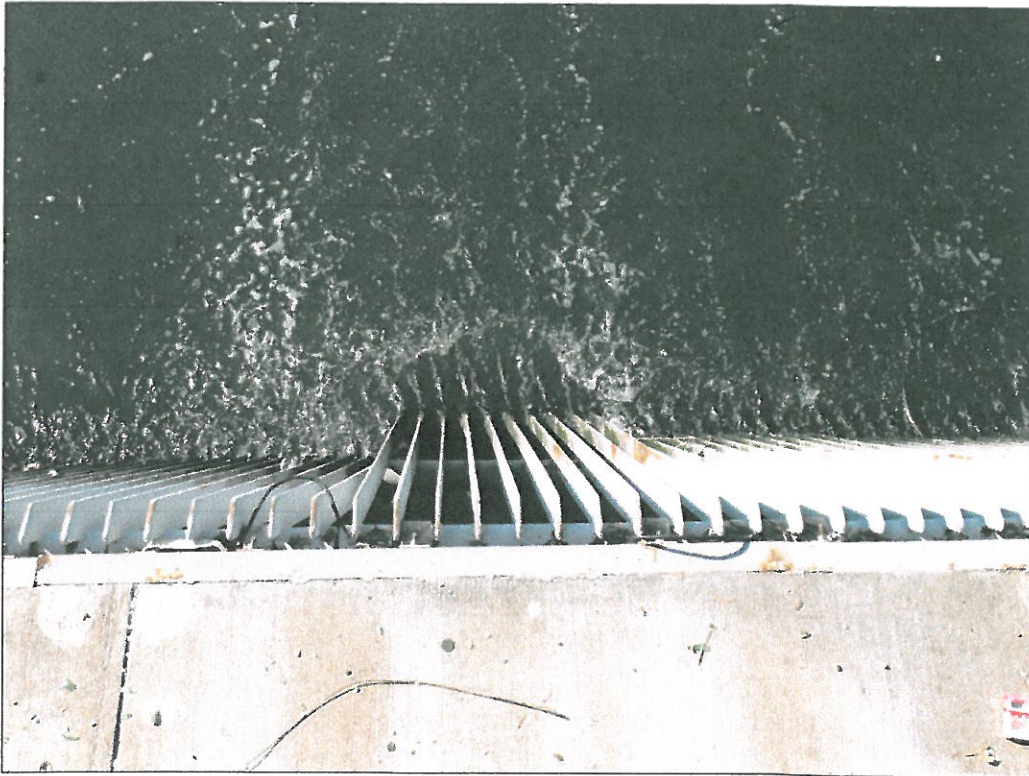
In the vicinity of the discharge flow on both Lakeside and Bayside, some Trash Rack sections do not return to rest on the toe curb as designed, but rather fall onto an adjacent rack. This permits a fairly large opening between adjacent racks for trash and other debris to transit into the pump impellers.

| Trash Racks | 18" - 24" of loose sediment in the vicinity of the divider screen extending out about 8 feet, tapering to zero.<br>Light marine growth with some localized areas of mussel accumulation. Heaviest accumulation at about mid-water.<br>In the vicinity of the discharge channel the toe of a trash rack has been displaced outward about 6" to 7". The Proximity of the adjacent trash racks will not allow enough room for proper settlement against the curb. |

Downstream/Bayside Trash Rack Displaced by Discharge Flow

9. Adjust or Modify the Trash Racks to allow room for flow-current displaced racks to realign into their correct positions.

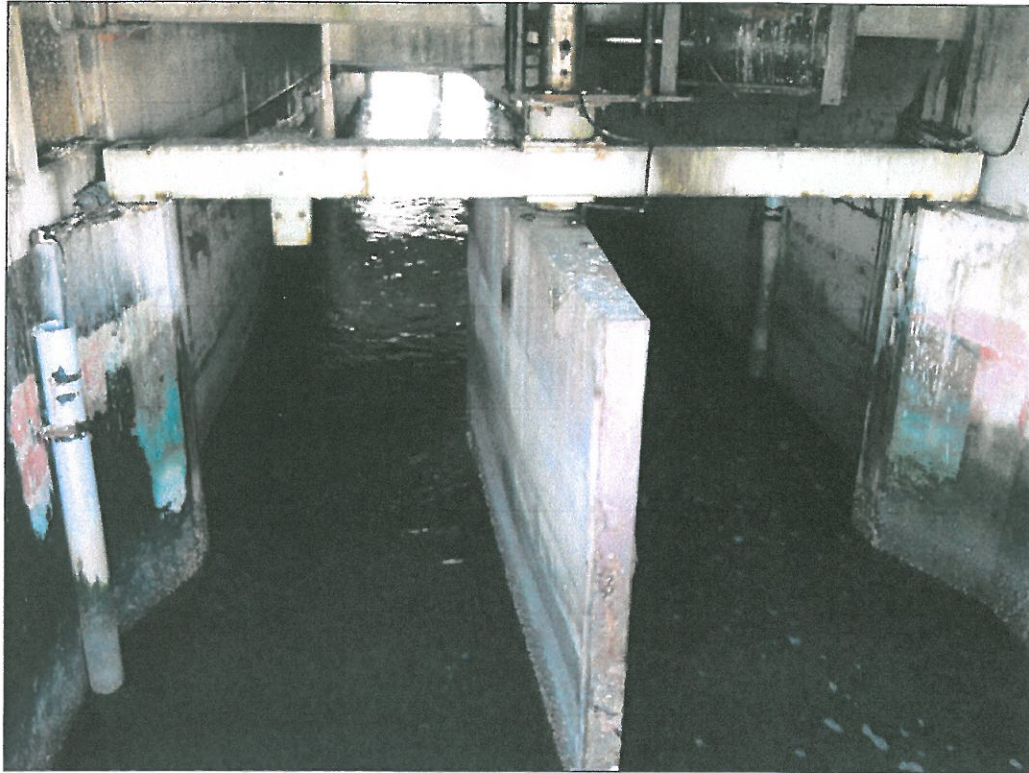
| GS-1 Lakeside | 50% remaining. Broken/loose top bracket. |
| GS-1 Suction Channel | 90% remaining. |

GS-1 Gate and Suction Channel  
Typical Location of Gate Graphite Anodes

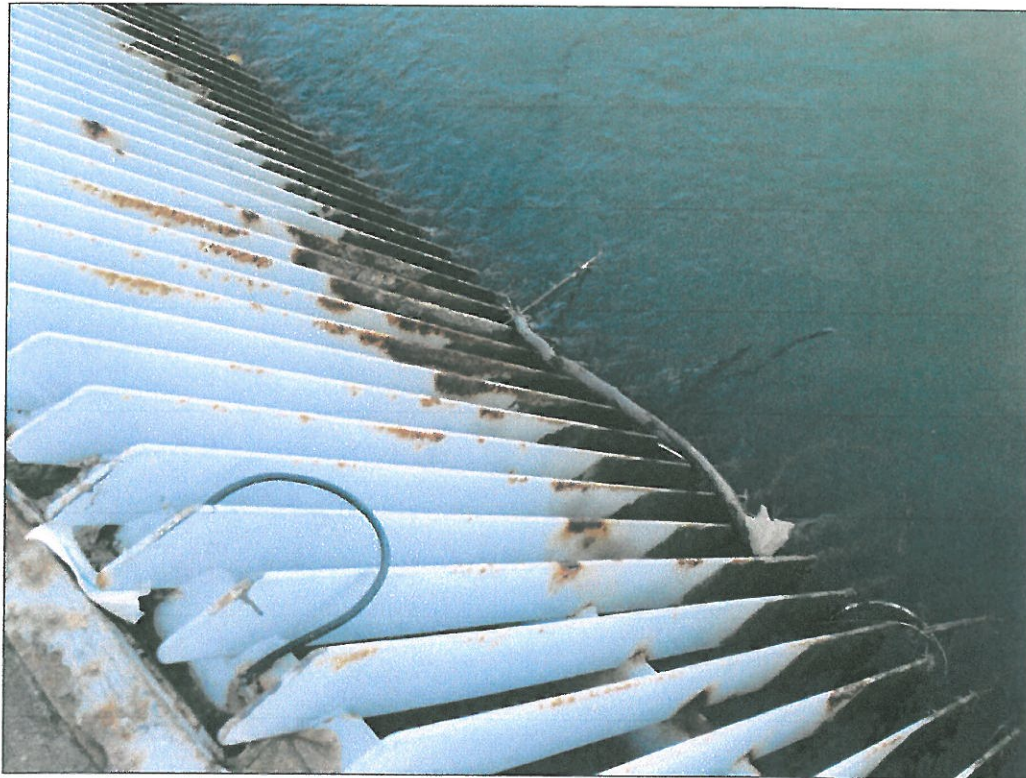
The Trash Racks have localized areas of corrosion where the existing ceramic coating system has failed. Although there is no imminent danger to the trash racks, if the corrosion is left to continue it will eventually degrade these elements.

| Trash Racks | Random areas of corrosion noted.<br>Light to moderate marine growth, approximately 1/2" thick, easily removed by hand. Some localized areas of mussel accumulation. Flow area is relatively clear. Heaviest marine growth is at mid-water level. |

Upstream Trash Rack - Corrosion Example

8. Repair the protective coating system on the corroded areas of the Trash Racks. Comparison with photos taken during a routine visit in June 2011 shows a large increase of corroded area.

5. Inspect the effectiveness of the Trash Rack coating system for additional signs of distress and possible coating failure. Determine if an alternative coating system is desirable or if repair to the existing coating system is a cost-effective option.

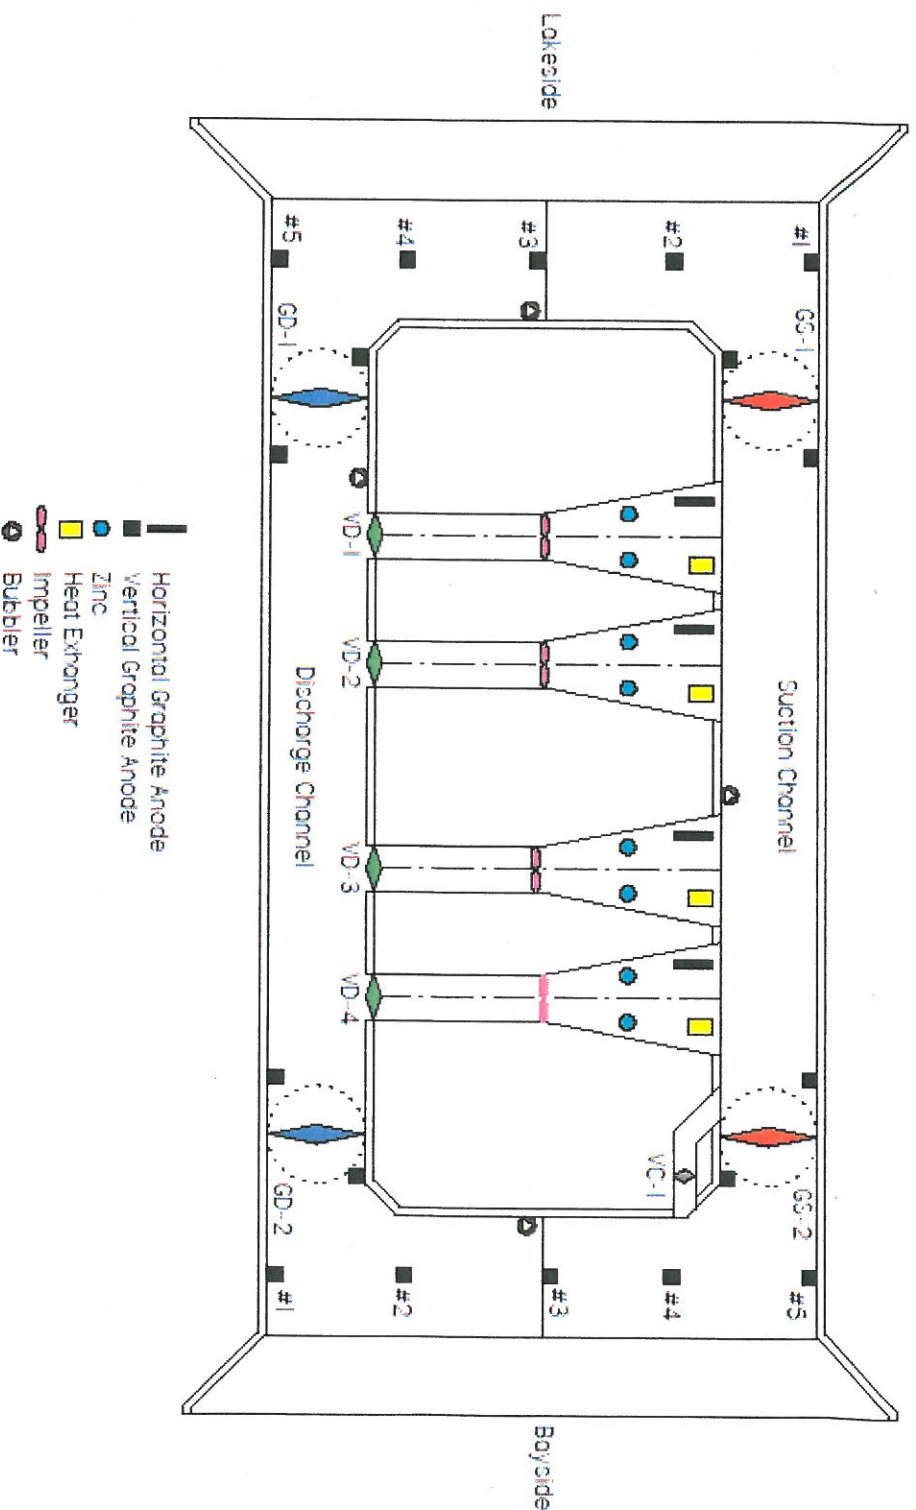
Some anodes were unable to be observed inside their PVC housings. Unexamined Horizontal Graphite Anodes (refer to attached diagram for locations):

- a. Lakeside #3 (at the divider screen)
- b. Gate GS-2 inside the suction channel
- c. Gate GD-2 inside the discharge channel
- d. Bayside #3 (at the divider screen)

5. Add larger ports or windows onto the PVC housings of the Horizontal Graphite Anodes noted as being un-inspectable underwater due to small ports in the housings.
