## **APPENDIX A**

**Northbrook Homes Fairview Site**

24850 Fairview Avenue

PRELIMINARY GEOTECHNICAL INVESTIGATION  
BOREL BANK PROPERTIES RESIDENTIAL SUBDIVISION  
FAIRVIEW AVENUE  
HAYWARD, CALIFORNIA

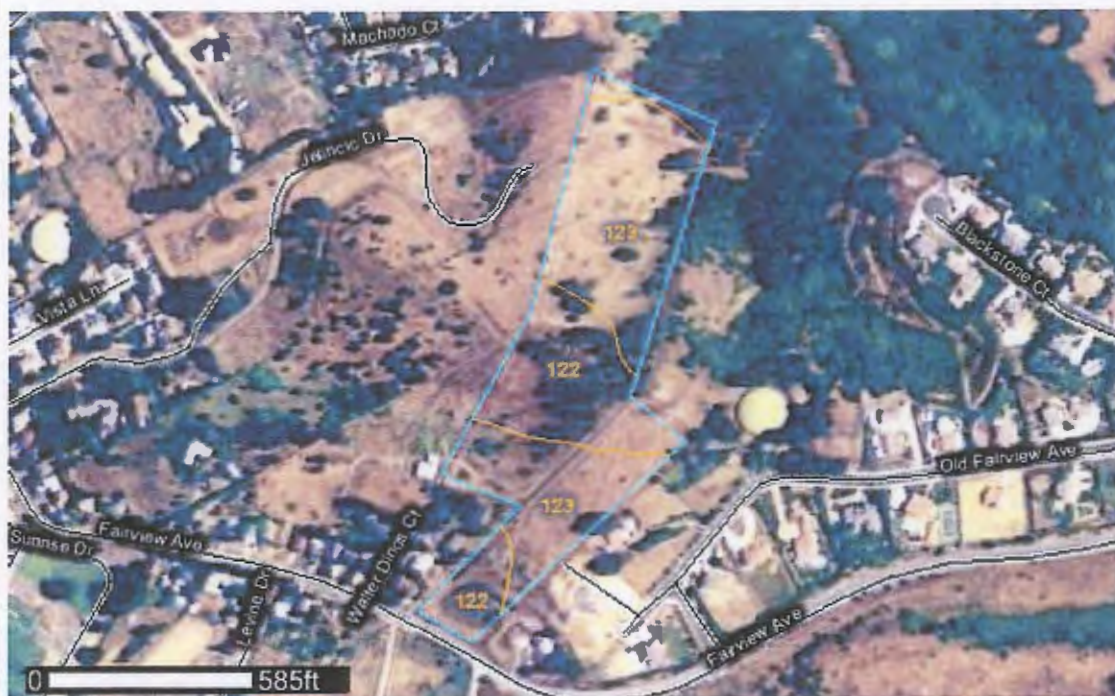
**Figure 8**  
**Soils Map**

The NRCS (2010) reports two soil type within the Property. A detailed map of this soil type can be found in Attachment 1, Figure 8. The soils mapped included the following type:

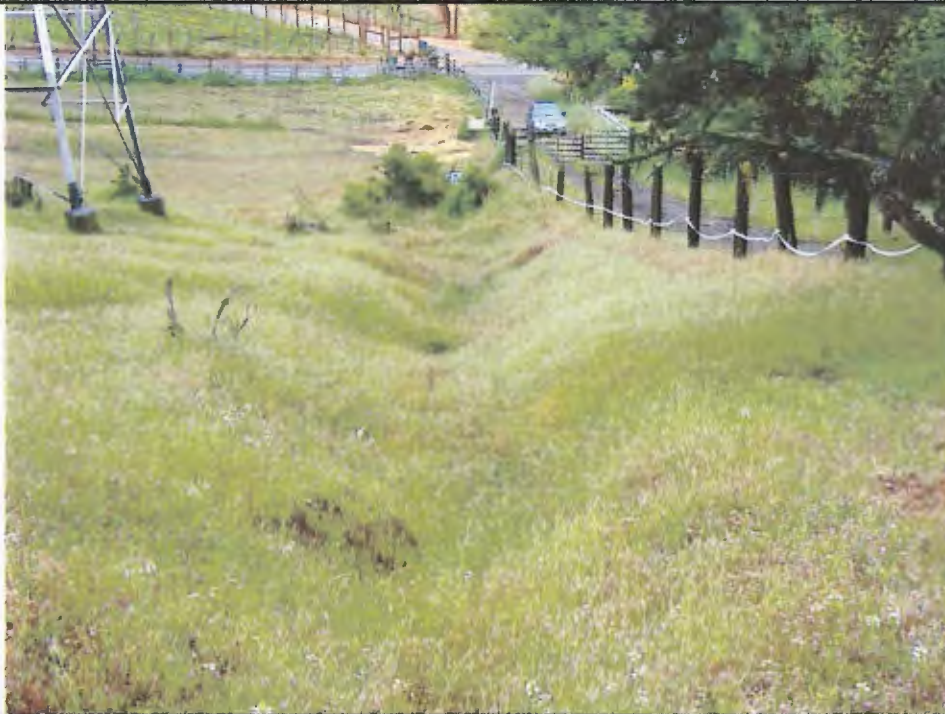
**Photo 1. View to the south of the incised drainage ditch along the western fence line.**

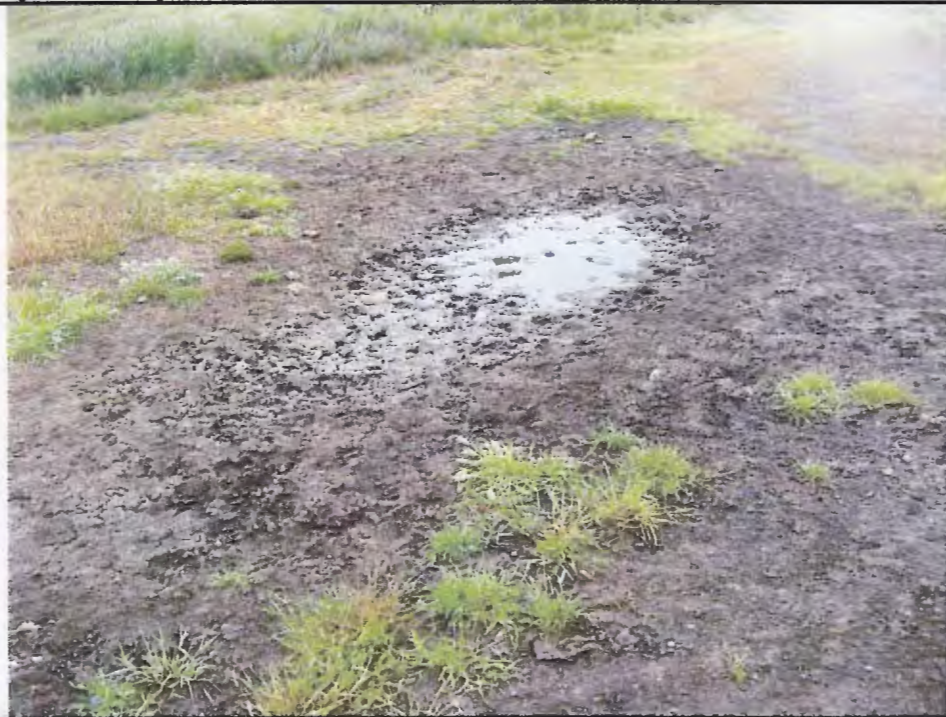
**Photo 4. View of the small potential seasonal wetland located near the western Property boundary.**

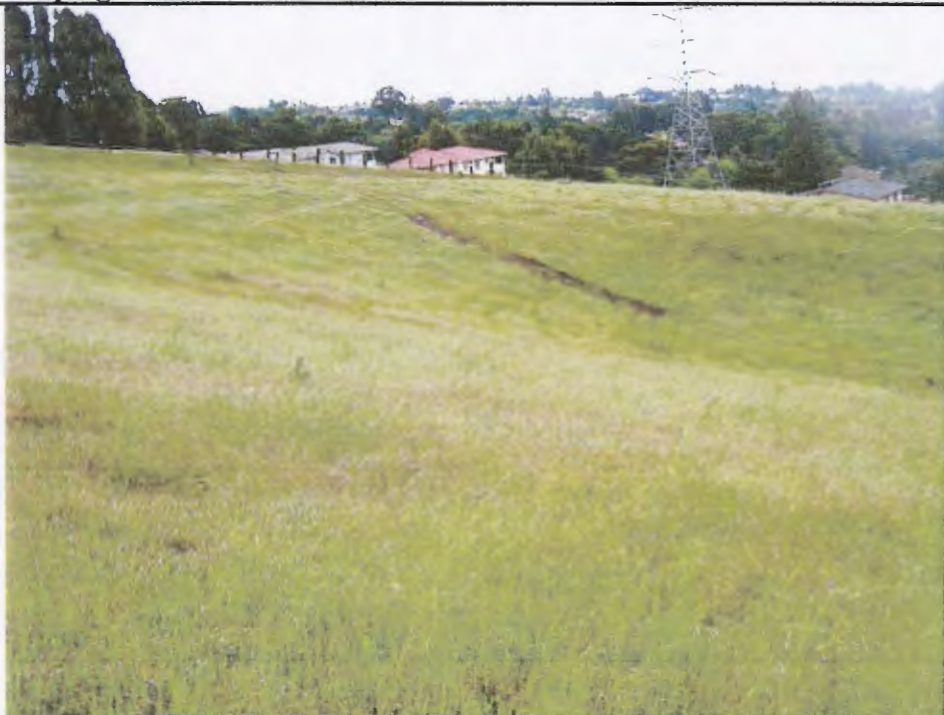
**Photo 6. View to the south of the hillside containing the potential seasonal wetland seep.**

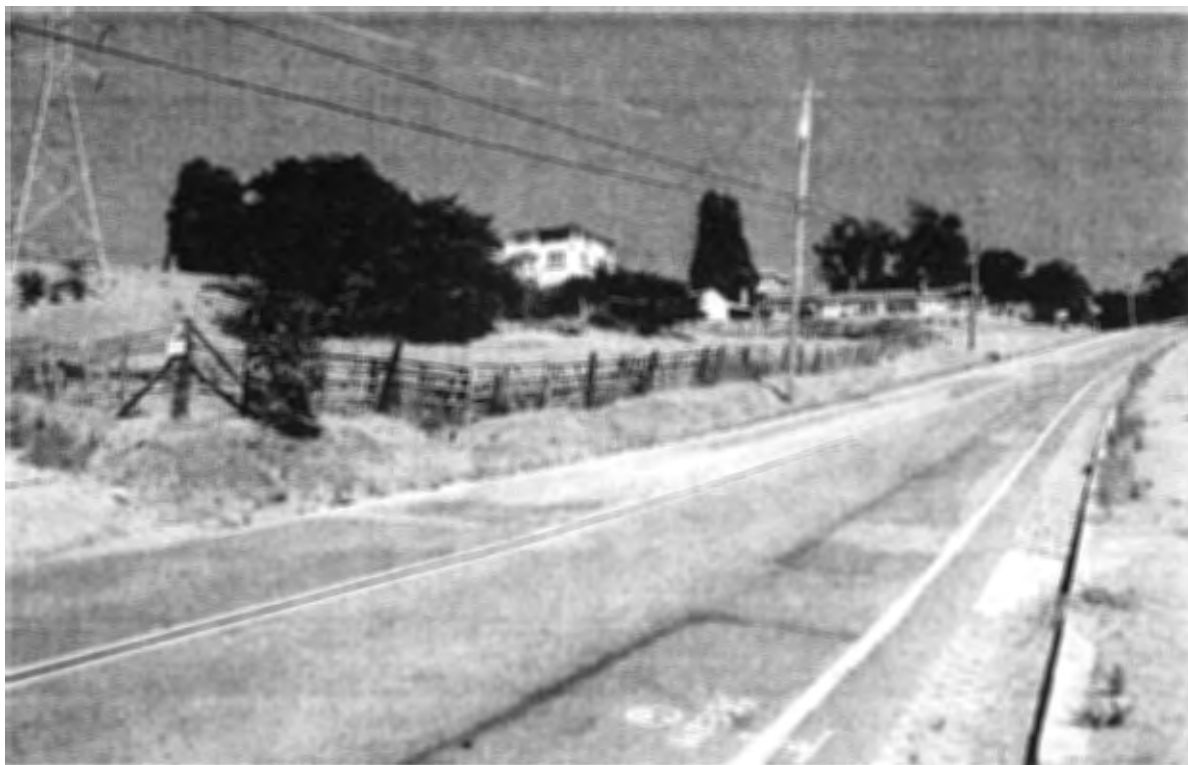
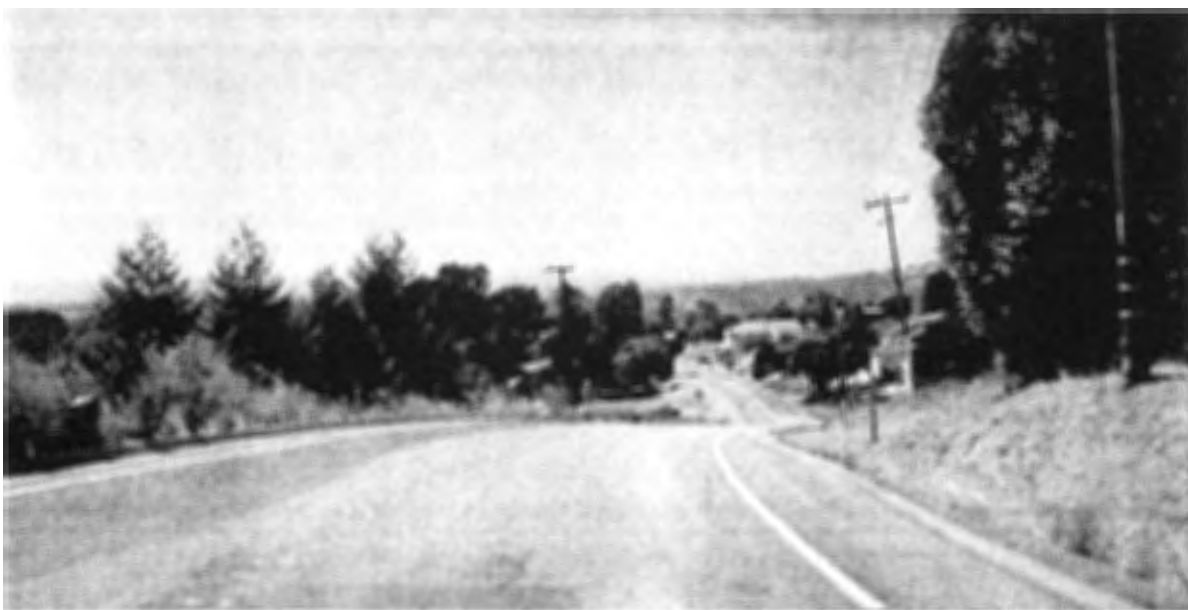
In the first photo, the proposed location of the project driveway is at the far left edge at the asphalt driveway. The view is uphill and shows the downgrade and the curves that limit the sight distance at the top of the hill. The second photo shows the downhill view with the proposed driveway not quite in view.
